Manhole Inspection Summary

Manhole # **S17GG_002MH**

Insp Date: **4/13/09 2:53 PM**

Location Address: **SIDE 1574 MORELAND**

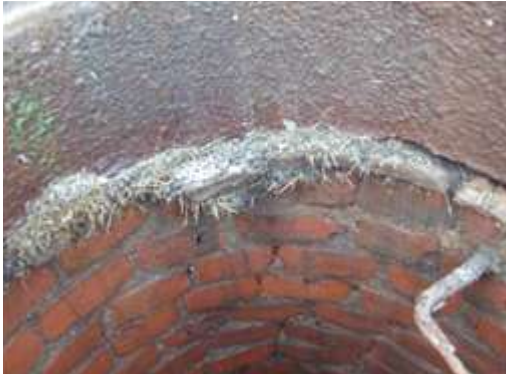
Defect 1

Condition: ☐ Sound ☐ Cracked ☒ **Root Intrusion** ☐ Loose Brick ☐ Deteriorated

ROOT INTRUSION

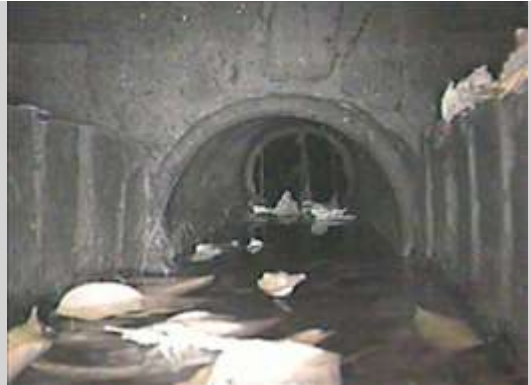
12 O'Clock Outflow

8 in. Circular Gravity Sewer
Pipe Out @ 12 O'Clock

Pipe Height: (in.) Direct
Pipe Material: **Clay** ☐ Pipe Lined
Invert Depth: **7.60** (ft.) Flow Characteristics: **Slow**
Deposits: ☒ None ☐ Mud ☐ Sludge ☐ Debris ☐ Grease
Silt Depth: (in.) Deposits Extent:
Infiltration: **None** Pipe Seal Cond: **Sound**

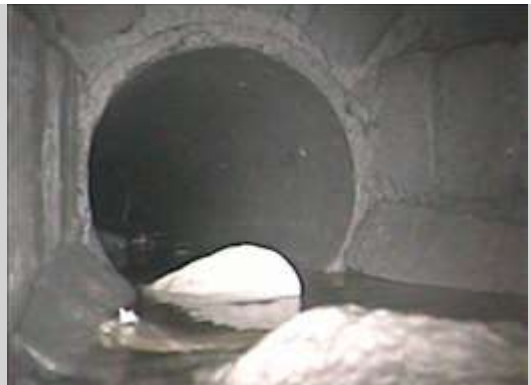
3 O'Clock Inflow

8 in. Circular Gravity Sewer
Pipe In @ 3 O'Clock

Pipe Height: (in.) Direct
Pipe Material: **Clay** ☐ Pipe Lined
Invert Depth: **7.51** (ft.) Flow Characteristics: **Slow**
Deposits: ☒ None ☐ Mud ☐ Sludge ☐ Debris ☐ Grease
Silt Depth: (in.) Deposits Extent:
Infiltration: **None** Pipe Seal Cond: **Sound**

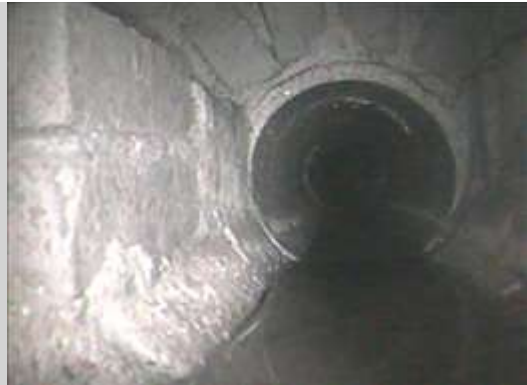
6 O'Clock Inflow

Infiltration: **None** Pipe Seal Cond: **Sound**

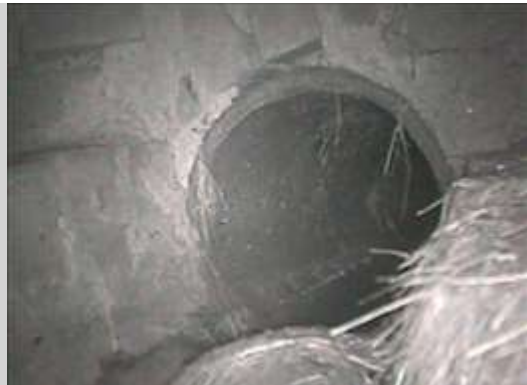
9 O'Clock Inflow

Infiltration: **None** Pipe Seal Cond: **Sound**

Connects To: **Stub connection / abandoned**
